# SHALER AREA SCHOOL DISTRICT

1800 Mt. Royal Boulevard  
Glenshaw, PA. 15116  
412-492-1200

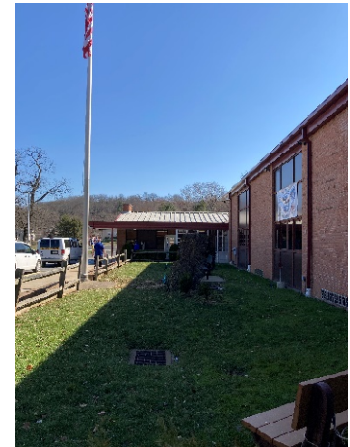
**SIZE:** 84,595 sq. ft. on approximately 10.75 acres

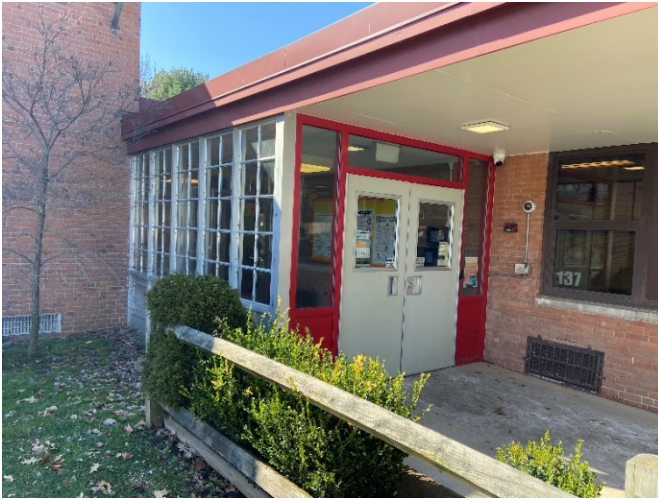
Burchfield Primary – Main entrance storefront leak air and water.

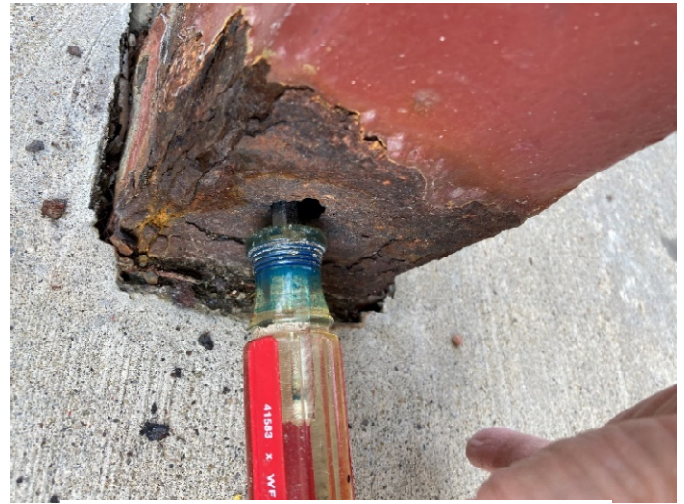
Canopy Column base Deteriorating at Sidewalk.

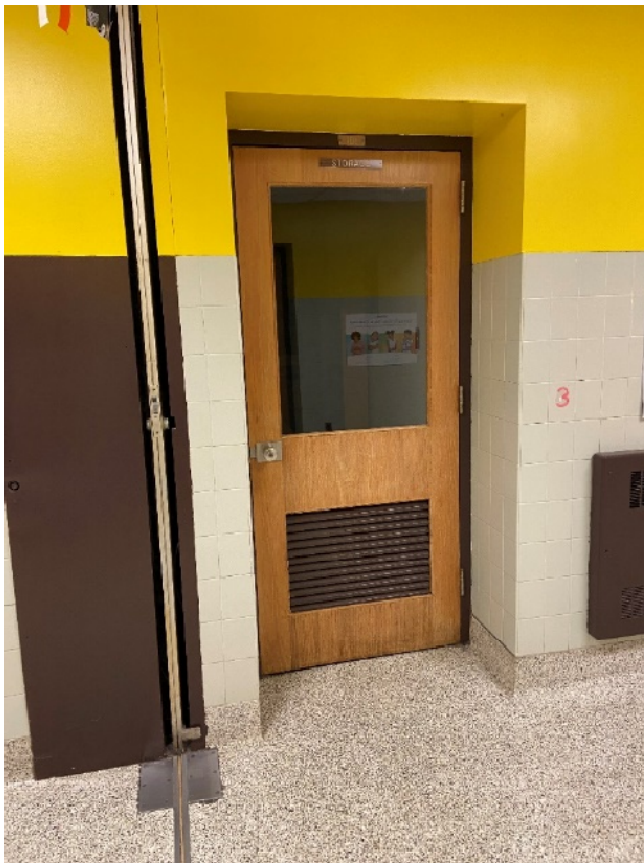
Typical Non-compliant Interior door -do not provide accessible clearances.

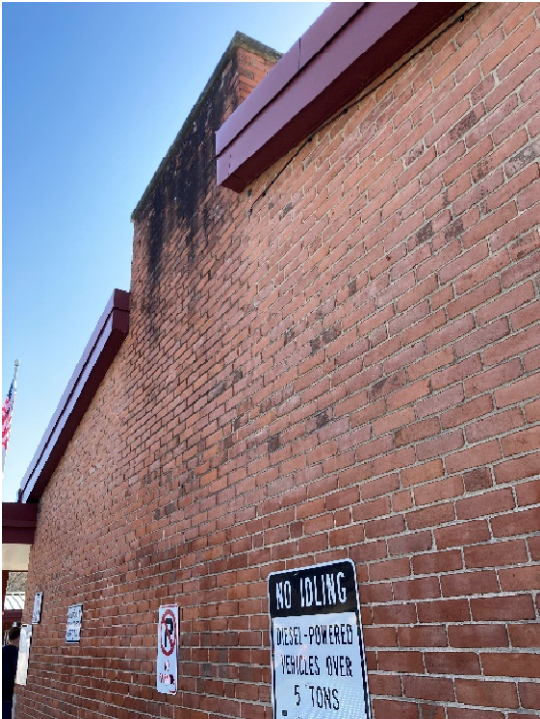
Brick Veneer / Mortar joints damaged due to water infiltration.

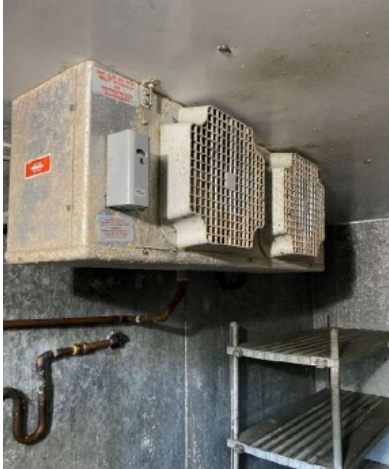
Interior of Walk-in Cooler.

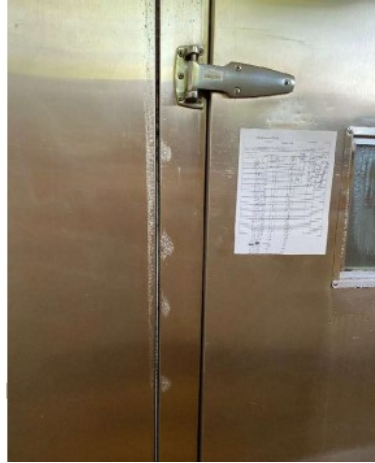
Condensation at degraded Walk-in Seam.

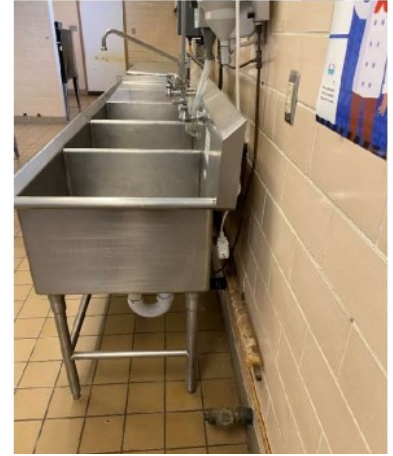
Exposed Plumbing and Gap at Rear of Sink.

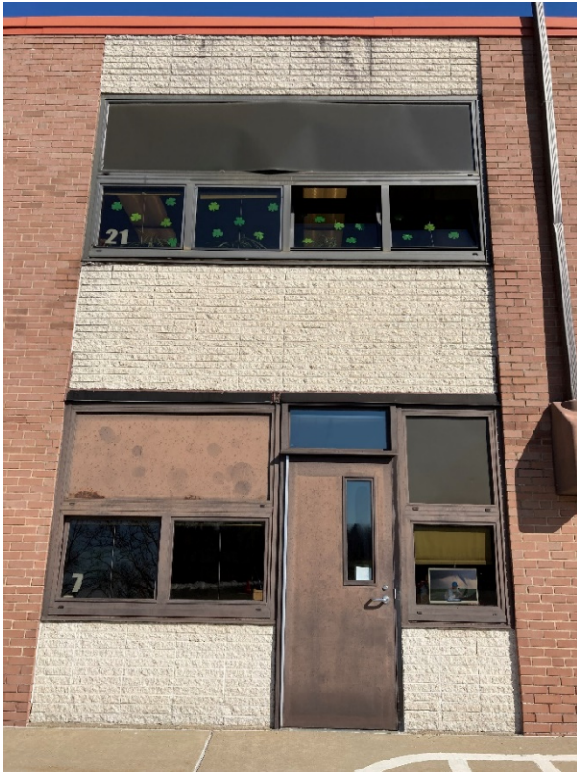
Windows, frames, panels, and doors are rusted and need to be replaced.

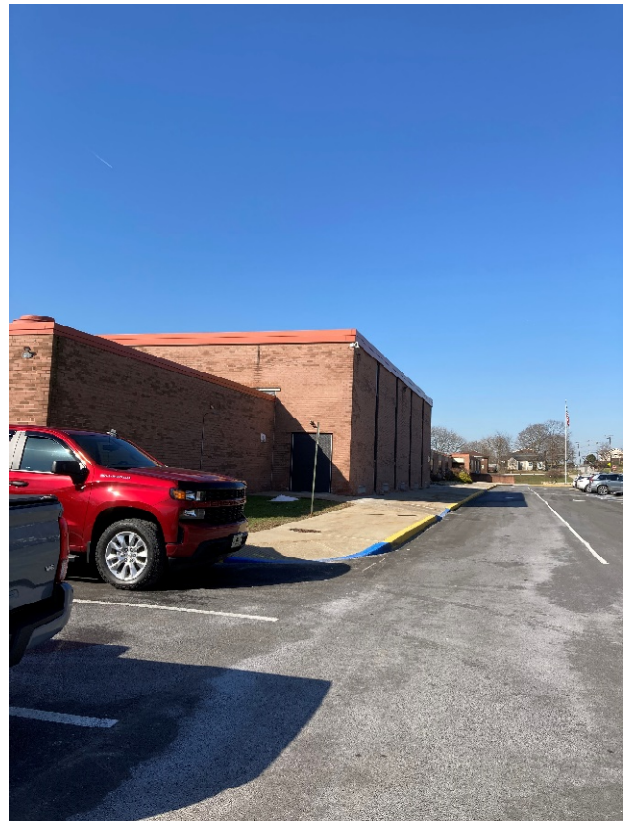
Marzolf Primary –Exit from Gymnasium.

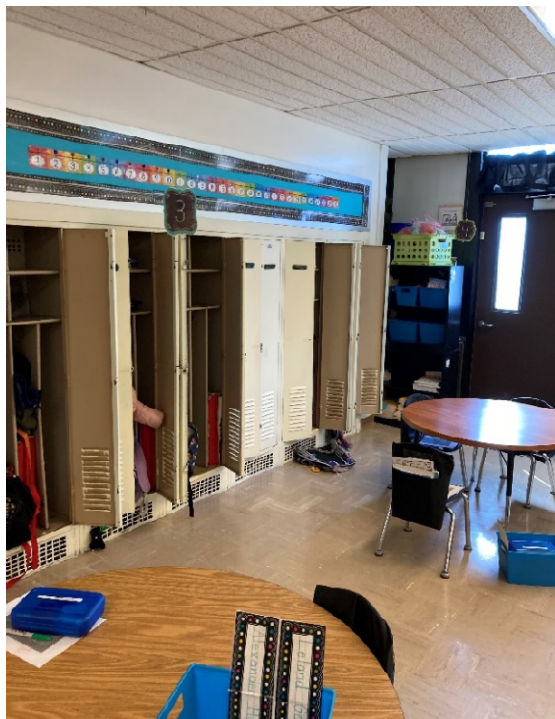
Lockers need to be replaced in kindergarten classrooms.

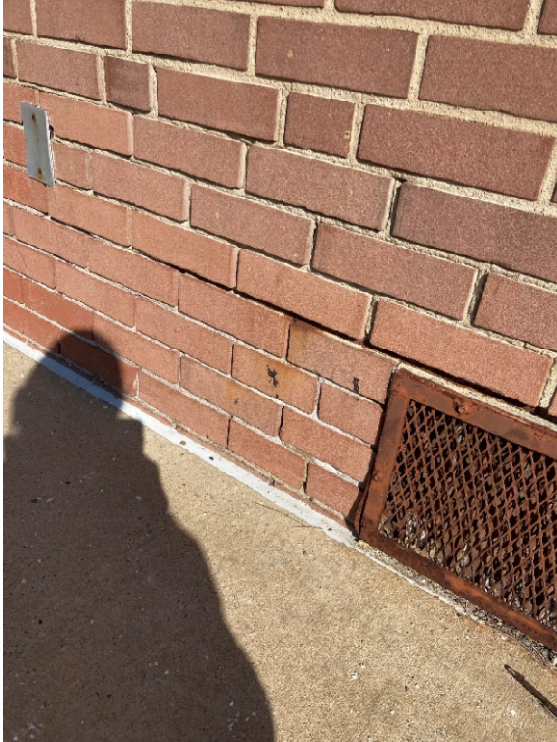
Exterior walls deteriorating due to exposure to weather.

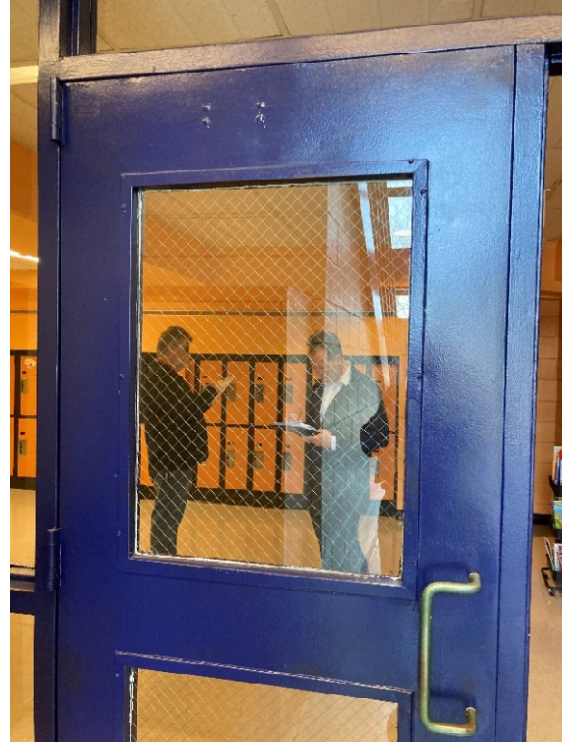
New hardware with lever type are required to meet ADA requirements.

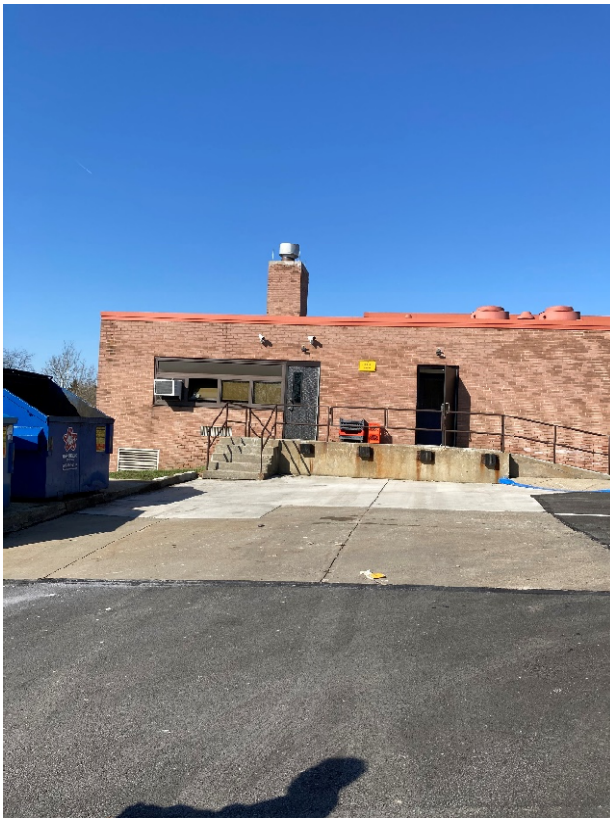
Exterior handrails at loading dock to be painted to prevent from corrosion.

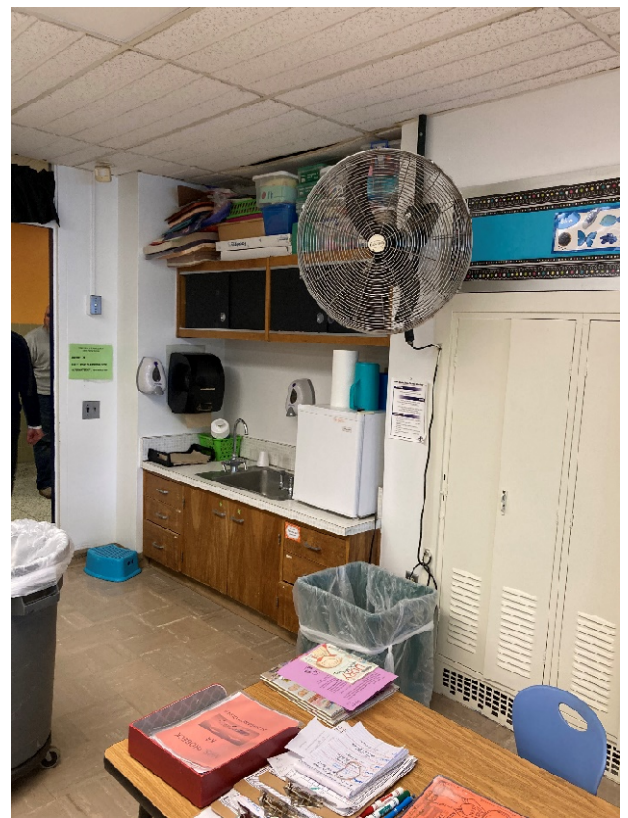
Sagging of lay in ceiling tile throughout the building. New humidity resistant panels should be installed.

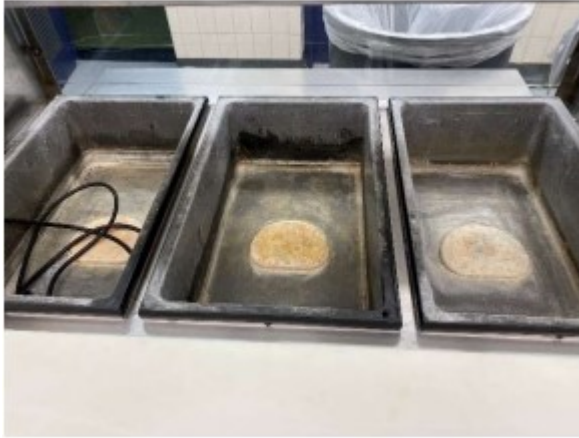
Hot Wells at Serving Line.

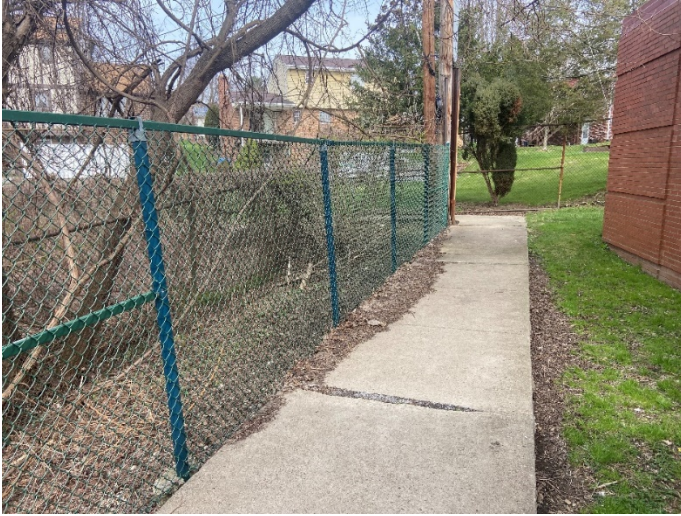
Sidewalk needs replaced that connects rear access from adjacent neighborhood for student walkers.

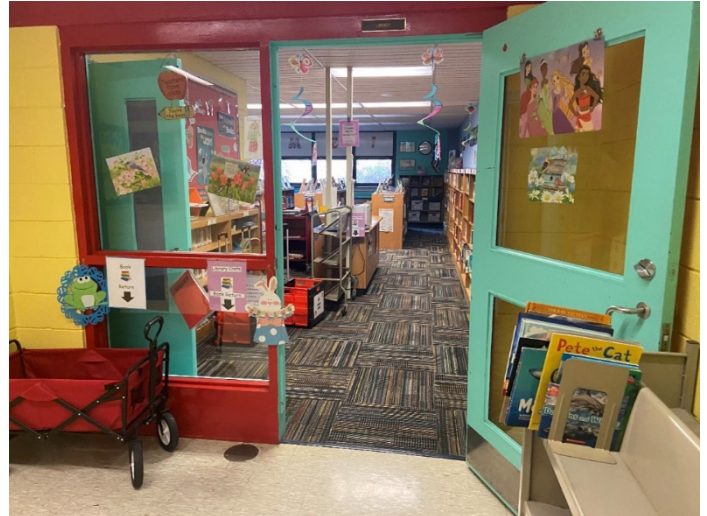
Shelving and tables in library need to be replaced.

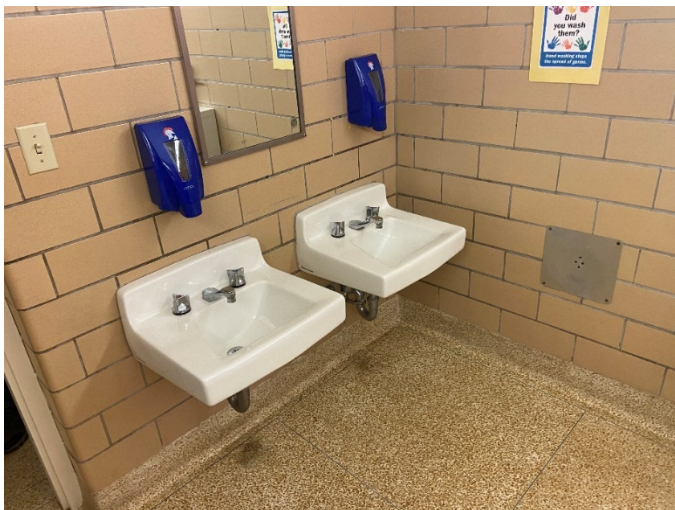
Existing lavatory fixtures do not meet ADA requirements.

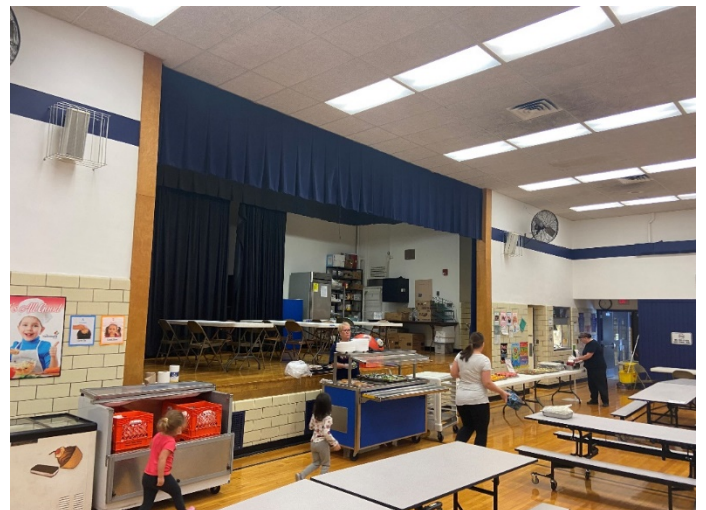
Gym / Cafeteria: Serves as dual function. Storage for chairs is lacking. Stage curtains and rigging are in fair condition. Multipurpose room is undersized.

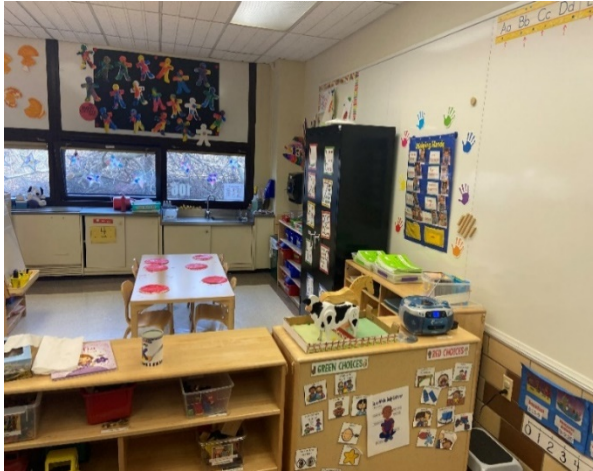
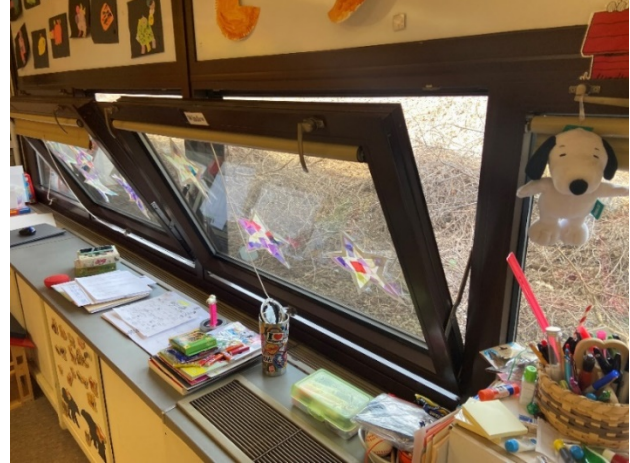
Existing cabinets integral to unit ventilators are in poor condition.

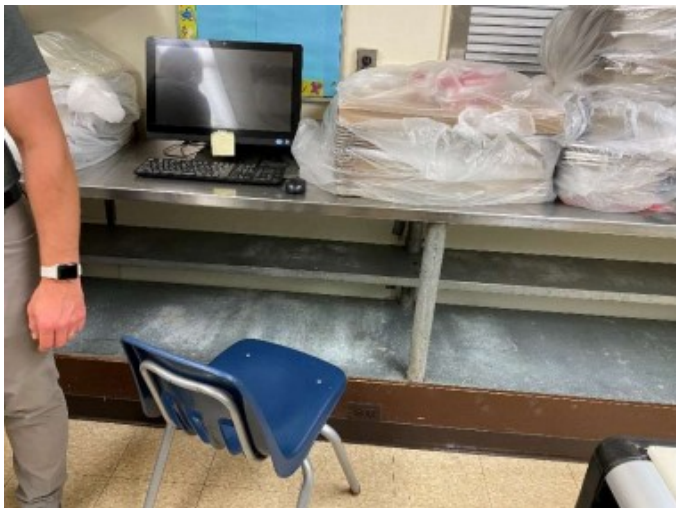
Kitchen serving /cashier window undersized.

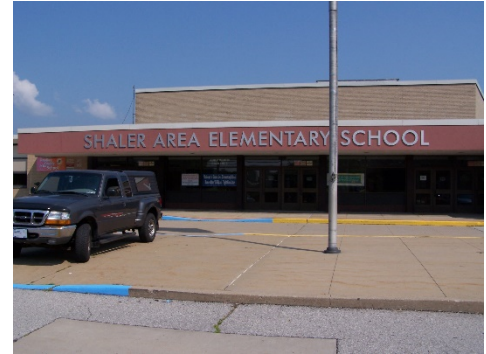
**BUILDING STRUCTURE:**

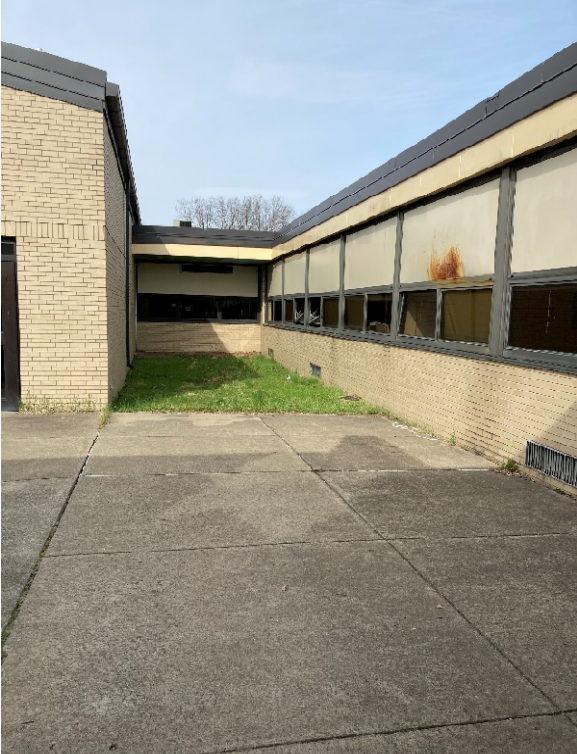
Building's exterior windows leak air and water at their perimeter and are in poor condition.

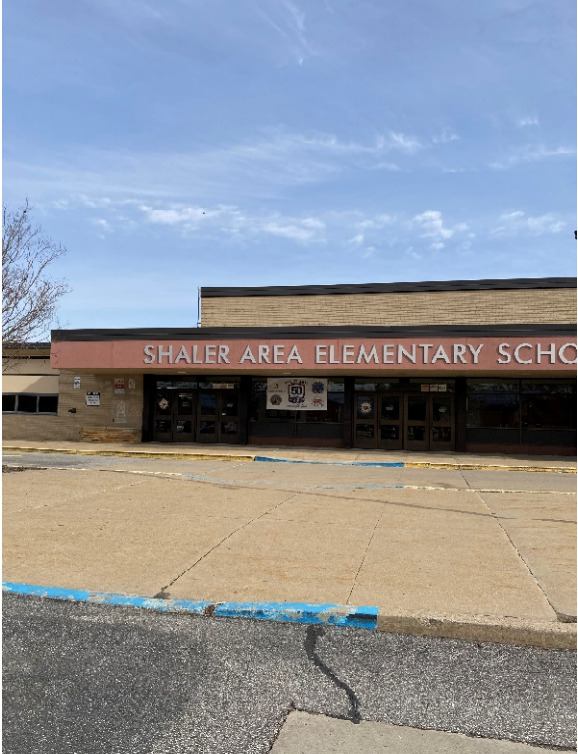
Concrete walkways are in poor condition. Building entrance and walkways are not protected from vehicles driving off the asphalt.

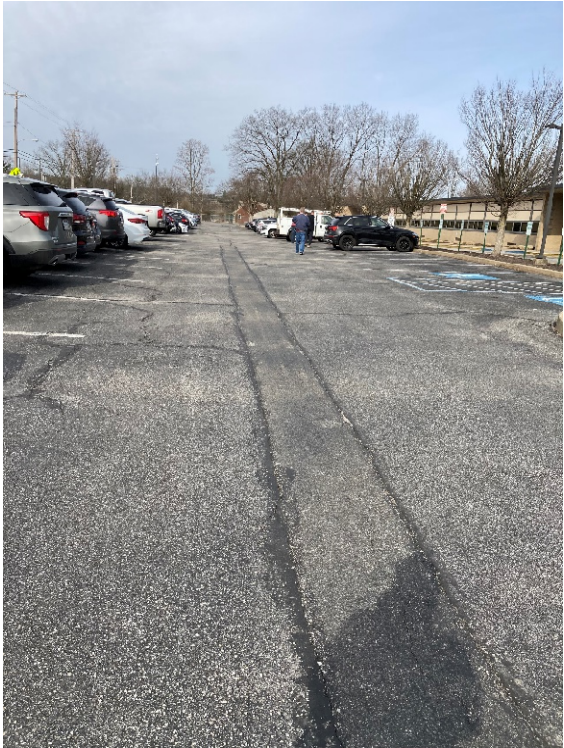
Asphalt in driveways is showing signs of cracking in the front.

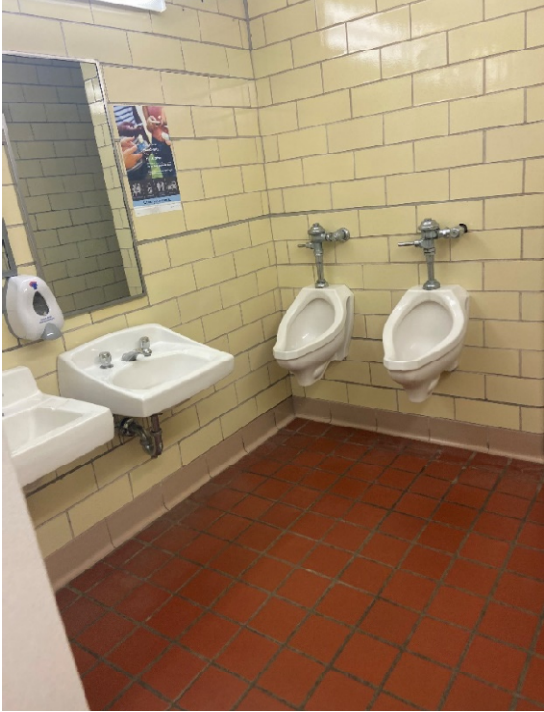
Renovate all building restrooms to provide adequate clearances for handicap; replace plumbing fixtures and accessories.

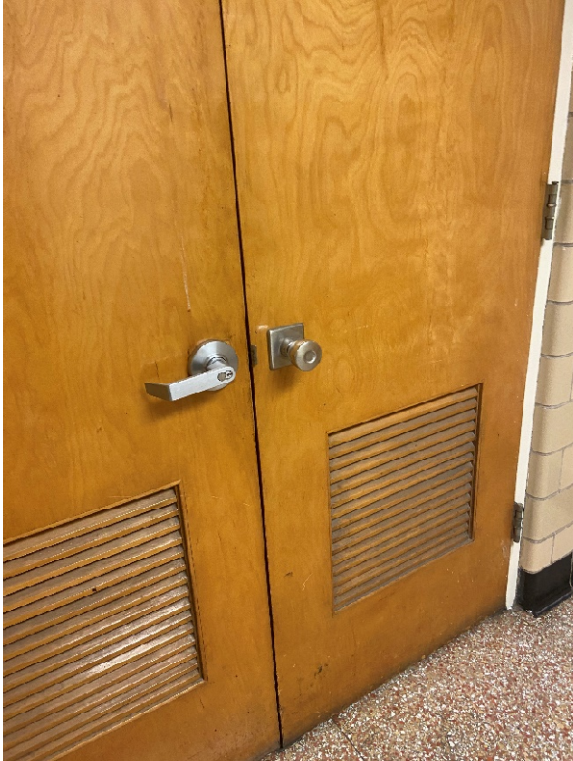
Replace non-compliant door hardware on interior doors with new lever-type locksets and panic devices at exit egress doors.

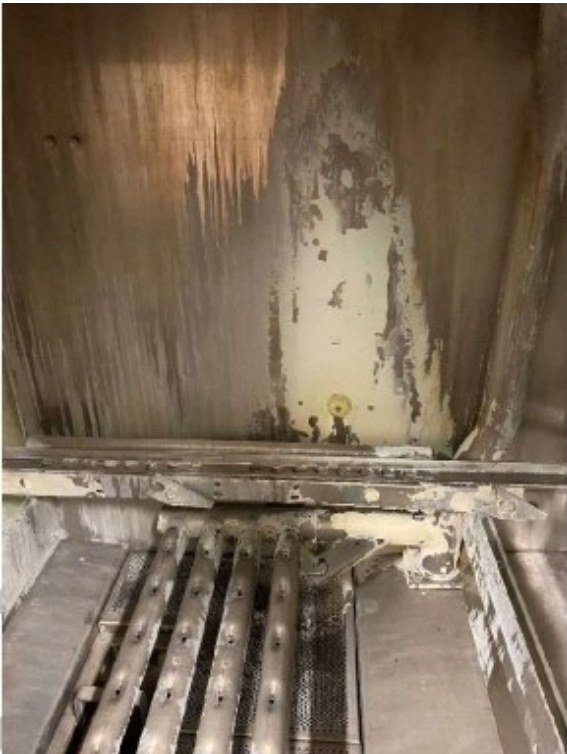
Interior of Dish machine.

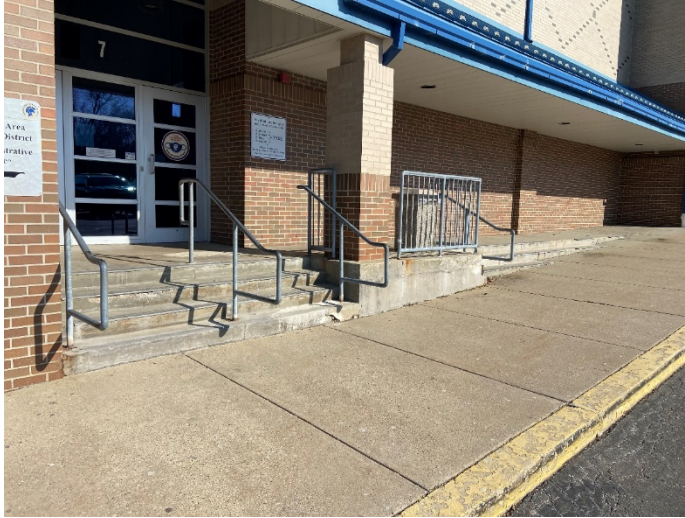
Shaler Middle school –Entrance stairs with metal inserts are in poor condition.

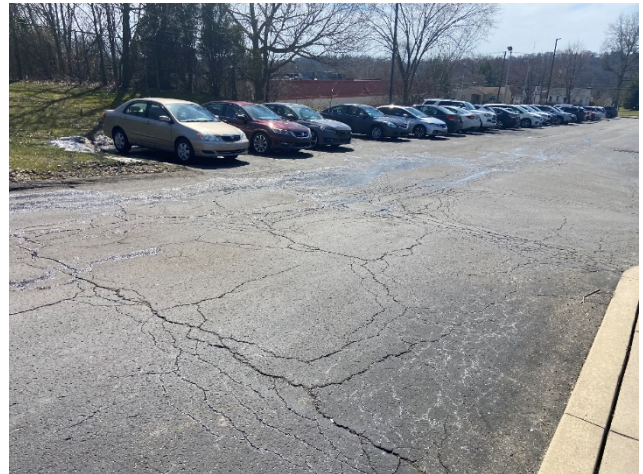
Existing parking lot showing signs of cracking in the front and rear lots.

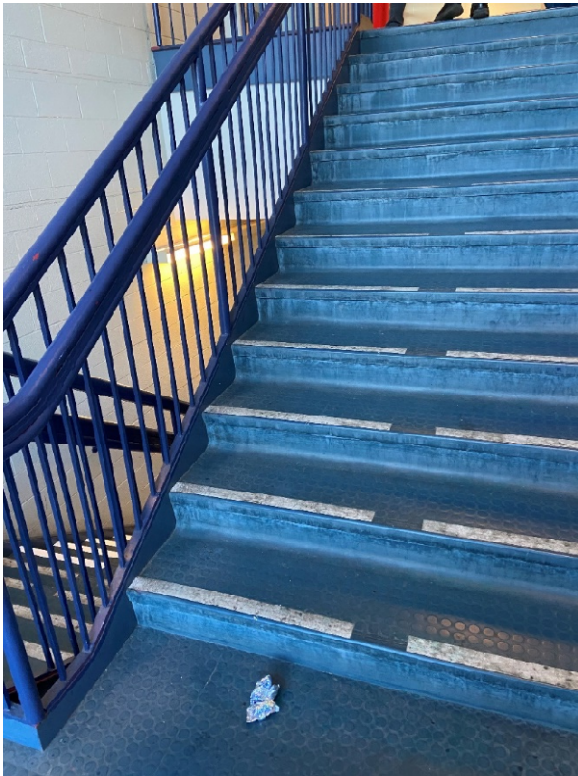
Existing Tread and risers are original and need replacement.

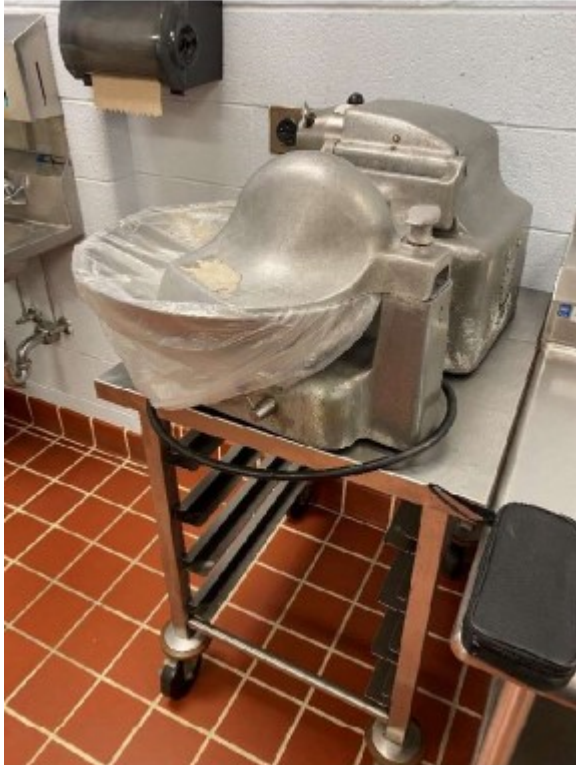
Food Chopper is original, and finish has degraded.

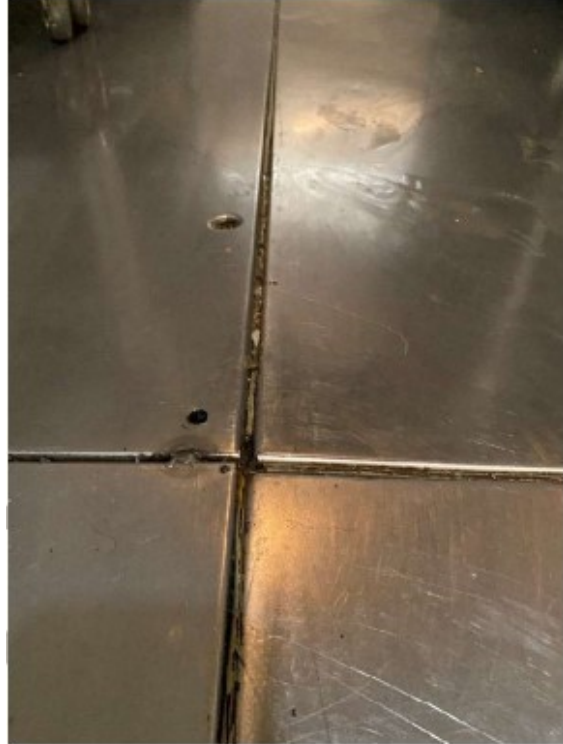
Walk-in cooler/freezer floors. The floor panel delamination and joint degradation occurring on both the ceiling and wall panels.

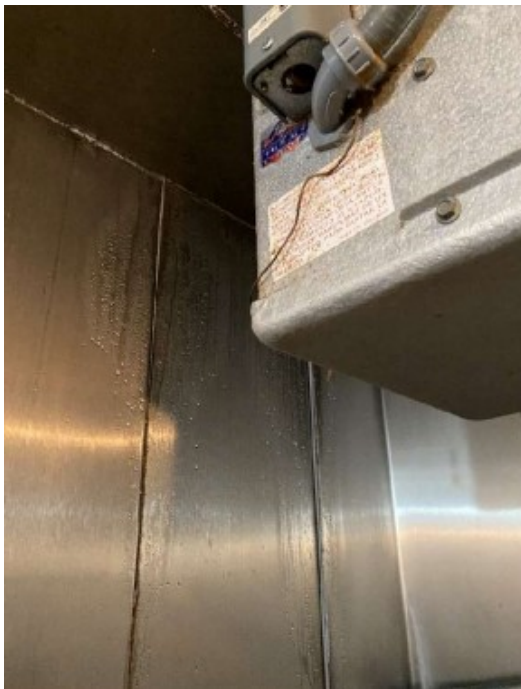
Condensation occurring Inside Walk-ins.

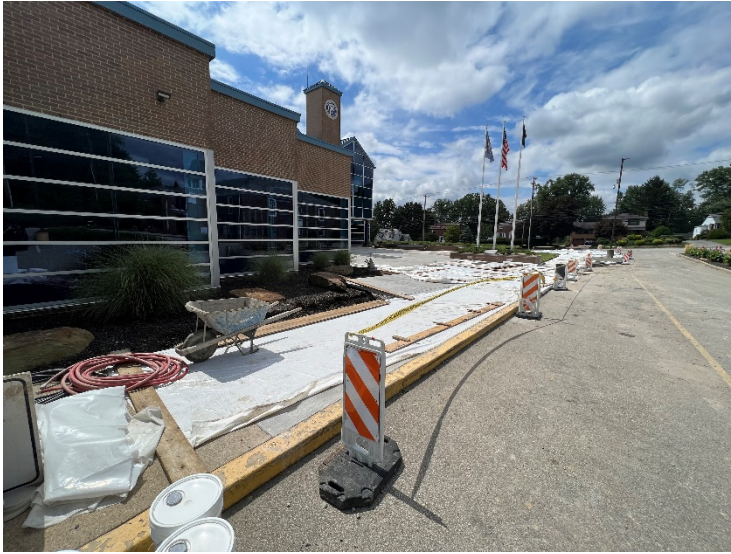
Existing entrance walkways have been replaced with new sidewalks.

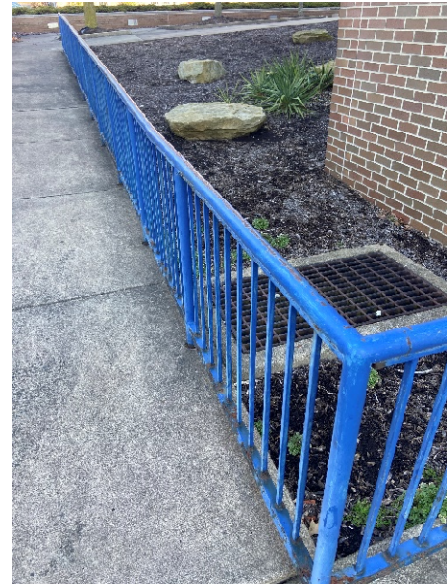
Existing site railings have paint chipping, rusting and require painting

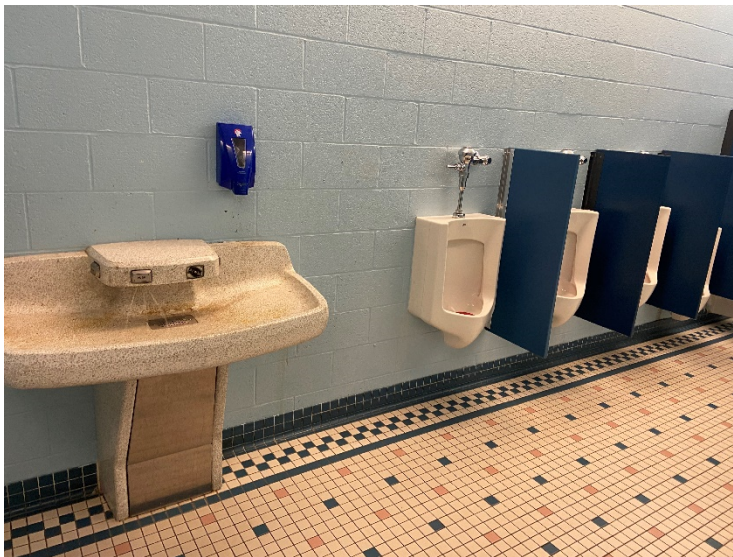
Gang toilet room plumbing fixtures appear to not meet ADA requirements, some have damaged, and corroded manual valves.

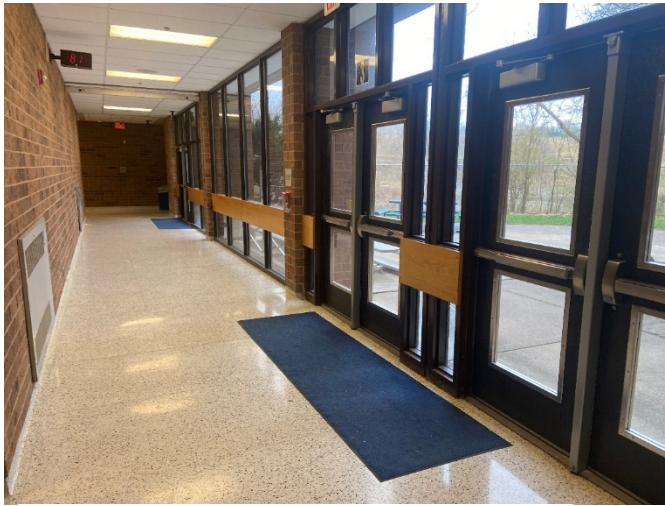
Main aluminum entrance doors need to be replaced.

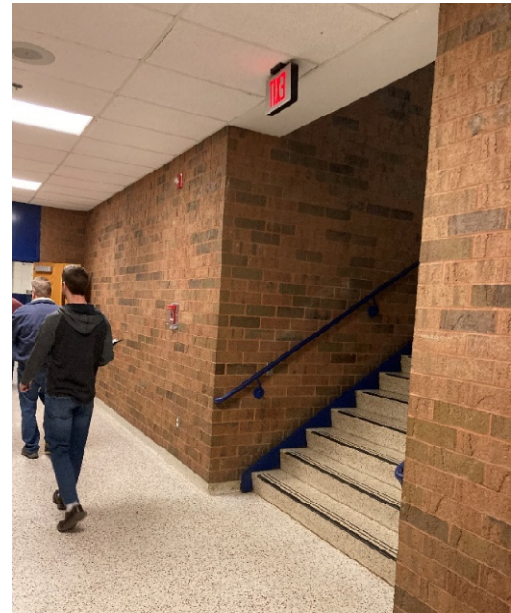
New rubber tread and risers need to be installed throughout the building.

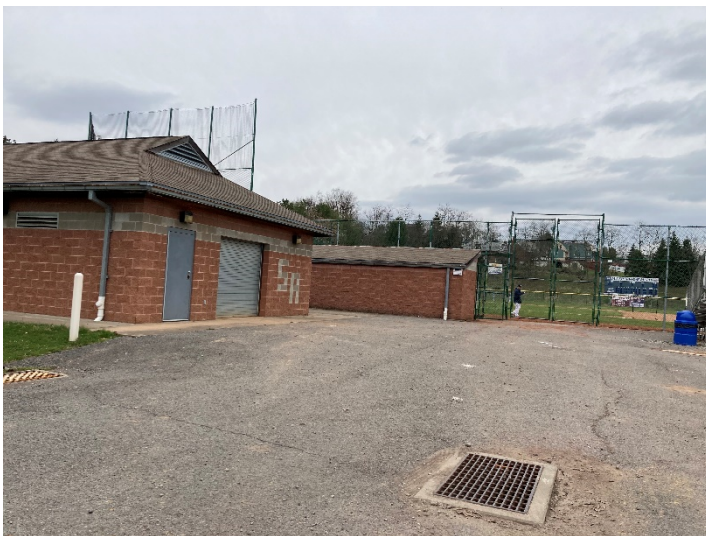
Athletic field support buildings roofing /fascia soffits, downspouts need to be replaced.

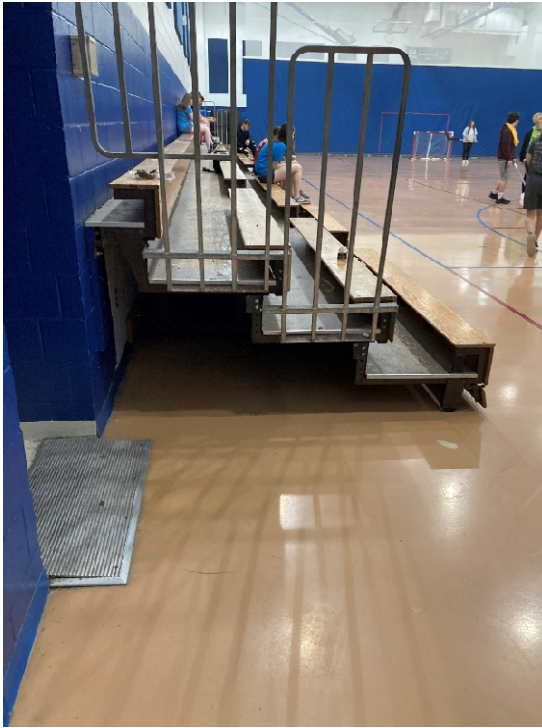
Existing bleachers are in poor condition.

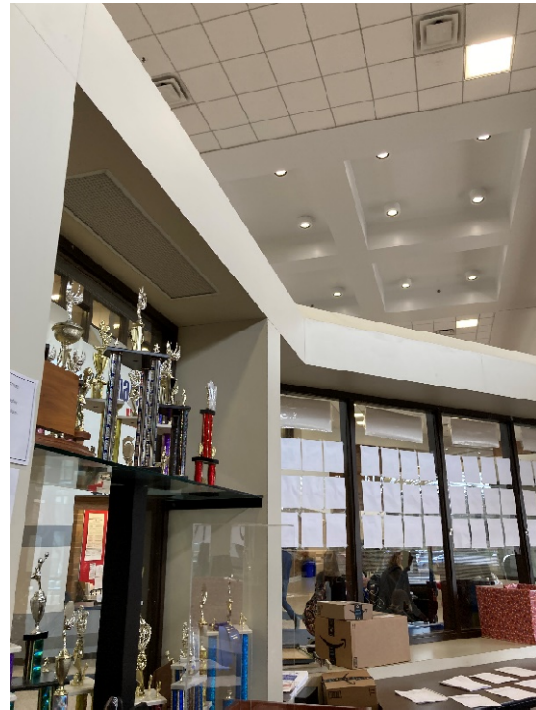
Lobby administration /guidance areas have acoustical issues through ceiling that need to be addressed.
